Stress levels of zoo animals are kept to a minimum with FLIR thermal imaging cameras

FLIR thermal imaging camera used to inspect health issues in animals at Artis Royal Zoo Amsterdam

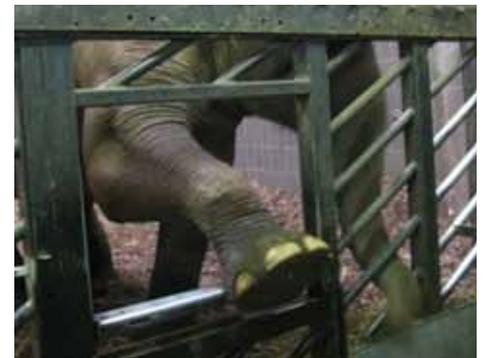
The FLIR P620 thermal imaging camera is accurate and completely safe for use with zoo animals.

The thermal imaging camera used by Valk is the FLIR P620. This highly sensitive thermal imaging camera contains an uncooled microbolometer detector that produces thermal images at a resolution of 640 x 480 pixels and a thermal sensitivity of 40 mK. Experienced veterinary thermographers

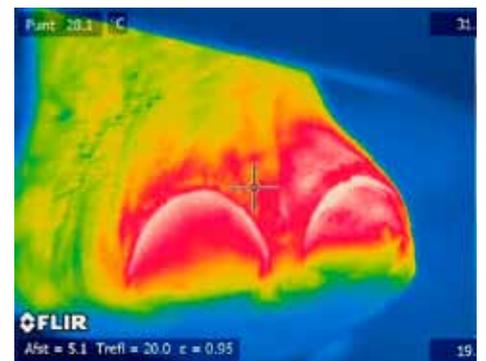
The elephants at Artis are trained to show their feet to their keepers for a regular thermal imaging inspection.

In the short time the FLIR P620 thermal imaging camera has been in operation it has certainly proven its worth, according to Valk. "We started using it on elephants, like I had seen it demonstrated in the States, taking thermal images of elephant feet to see if they had infections or other abnormalities."

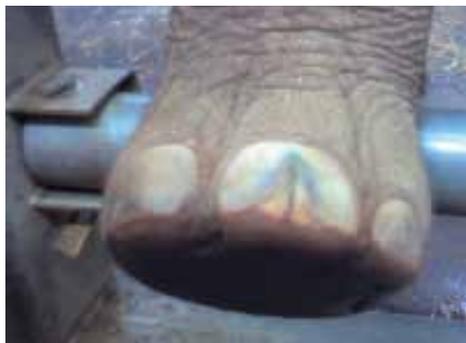
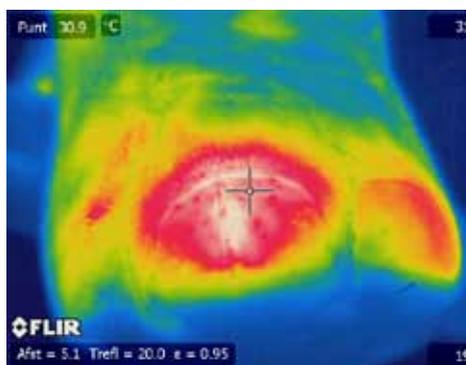
Thermal imaging can be used to accurately track the recuperation process of animals recovering from an inflammation or injury. This thermal image shows an elephant foot after treatment. The heat pattern is returning to normal, indicating that the treatment was successful.

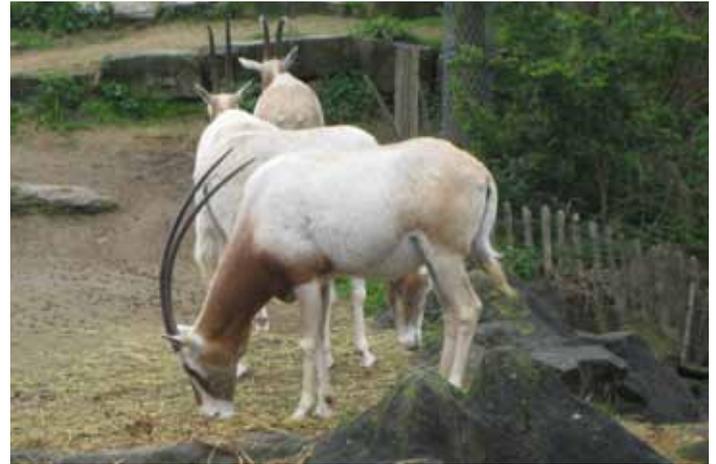
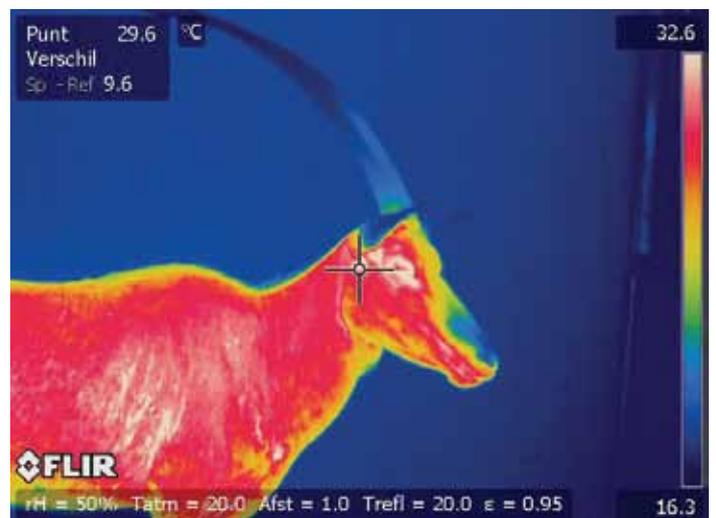
This Scimitar Oryx has a swollen jaw. The thermal image shows that the swollen area is not significantly warmer, so no drugs were administered. Less than 2 days later the swelling was gone.

But the thermal imaging camera is used more and more with other animals as well. "In one case a Scimitar Oryx had a swollen jaw. The keepers noticed the swelling but they were unsure about the cause. It could be that it was just some cud – food regurgitated by a ruminant to chew on it a second time – that was stuck there, but it could also be an inflammation. The thermal image showed no signs of inflammation, since the area showed up as having a regular temperature. Secure in the knowledge that it was probably just cud we took no further action and over time the swelling subsided. In this case the use of the thermal imaging camera saved the Scimitar Oryx from unnecessary sedation."

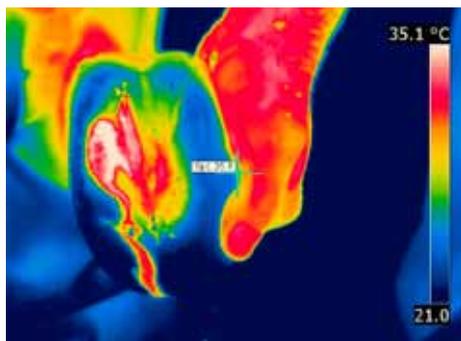
This thermal image shows a zebra hoof. The warm fluid running down the hoof is pus discharge caused by an infection that was cut open by a veterinarian. The thermal imaging camera provided crucial feedback during the operation.

In another case the thermal imaging camera provided crucial feedback for the operating veterinarian. "We had a zebra with a limp and an inspection with the thermal imaging camera showed it had an infected hoof. When the vet started to

remove the infected tissue I continued looking at it with the thermal imaging camera and urged the veterinarian to cut even deeper. I felt a little worried, for I didn't want to cause unnecessary damage to the zebra, but the thermal image turned out to be correct. In the end we found the infection and managed to remove it. If we wouldn't have had the thermal imaging feedback we would never have dared to go in that deep."

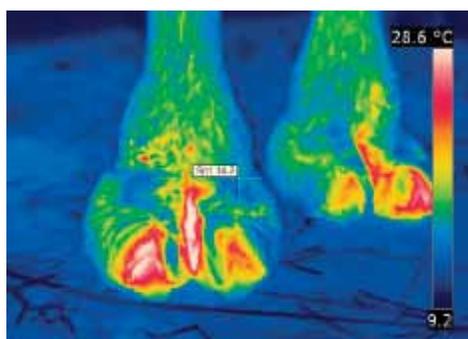
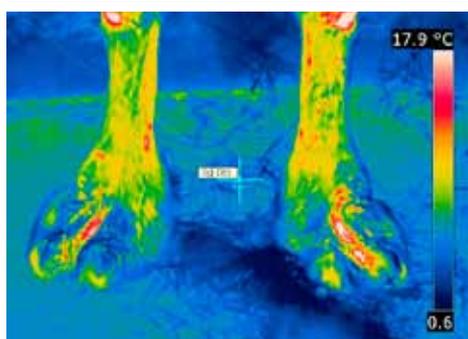
The top image shows the toe of a camel with a hot area indicating an infected toe. The lower thermal image shows the feet of that camel after two weeks of treatment with antibiotics.

In some cases the thermal imaging camera provides solutions when all other diagnostic methods failed. "We had a camel that was limping and we just couldn't find out what was causing it. Physical inspections and X-rays didn't bring us any closer to finding the cause, so I took out my thermal imaging

camera and I immediately spotted a warm area in one of the toes. It turned out to be an inflammation, which was successfully treated with anti-inflammatory drugs."

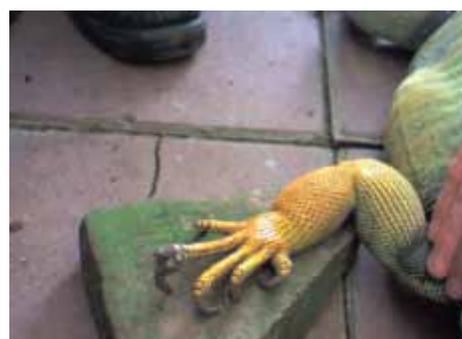
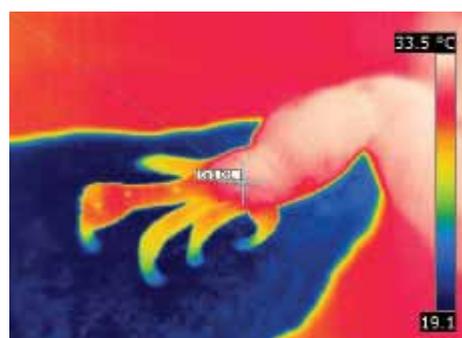
This thermal image shows the claw of a green iguana with a suspicious swelling. The swollen toe is much warmer than the other toes, indicating an infection.

An often made assumption is that veterinary thermography with cold-blooded animals is not feasible, but Valk had a case that proved this assumption to be wrong. "We had a green iguana with a swollen toe and we suspected it to be inflamed. But since

iguanas are very sensitive creatures you don't just administer antibiotics if it's not absolutely necessary. But using thermal imaging proved to be a challenge, since the iguana is kept in a warm room and its body temperature is almost the same as the room temperature. So I placed a cold stone underneath the iguana's claw, cooling down the claw slightly. The swollen toe turned out to be warmer than the rest of the claw, so we decided to administer the antibiotics."

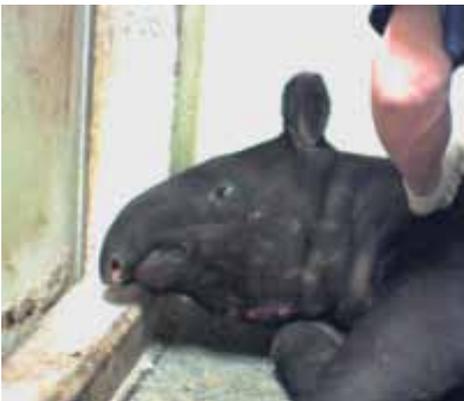
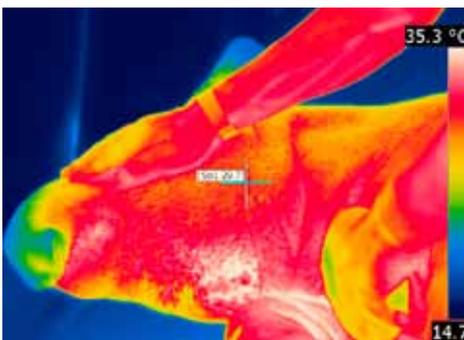
The thermal image of this Tapir shows that the abscess below the jaw is warmer than the surrounding tissue, which warrants further investigation.

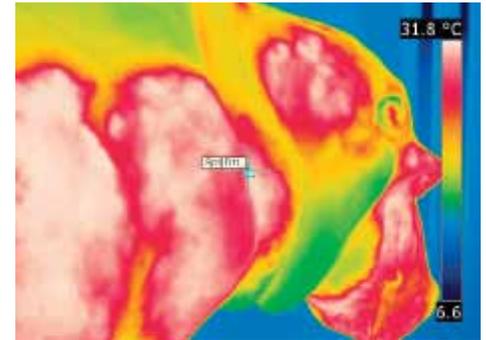
Thermal imaging helps to determine the skin temperature of this hippopotamus with a very serious rash from a safe distance.
