## Thermal imaging helps Globus Baumarkt identify insulation problems

# APPLICATION STORY

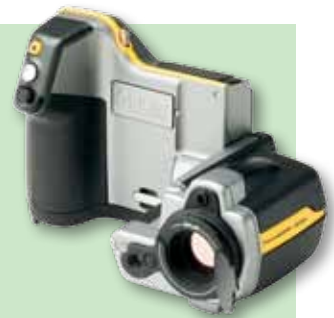
Globus Baumarkt have both the FLIR B335 and the FLIR B365 thermal imaging cameras. The B-Series of portable thermal imaging cameras take ergonomics, weight and ease-of-use to a new level. Usability is key: FLIR has translated user feedback on comfort and clarity into a series of thermal imaging cameras that have comprehensive and innovative features, specially designed for building environments. The FLIR B335 and the FLIR B365 share the following features:

320x240 pixel resolution

Temperature range -20° C to 120° C

<50 mK sensitivity

Picture-in-picture

Humidity and insulation alarm

3.5" LCD touch screen

Integrated 3.1 Mpixel digital camera

Bluetooth connectivity with FLIR Meterlink™
